# ANNUAL REPORT FOR 2002

**Tucker Mitigation Site  
Currituck County  
Project No. 6.049009T  
TIP No. R-2228WM**

Prepared By:  
Office of Natural Environment & Roadside Environmental Unit  
North Carolina Department of Transportation  
December 2002

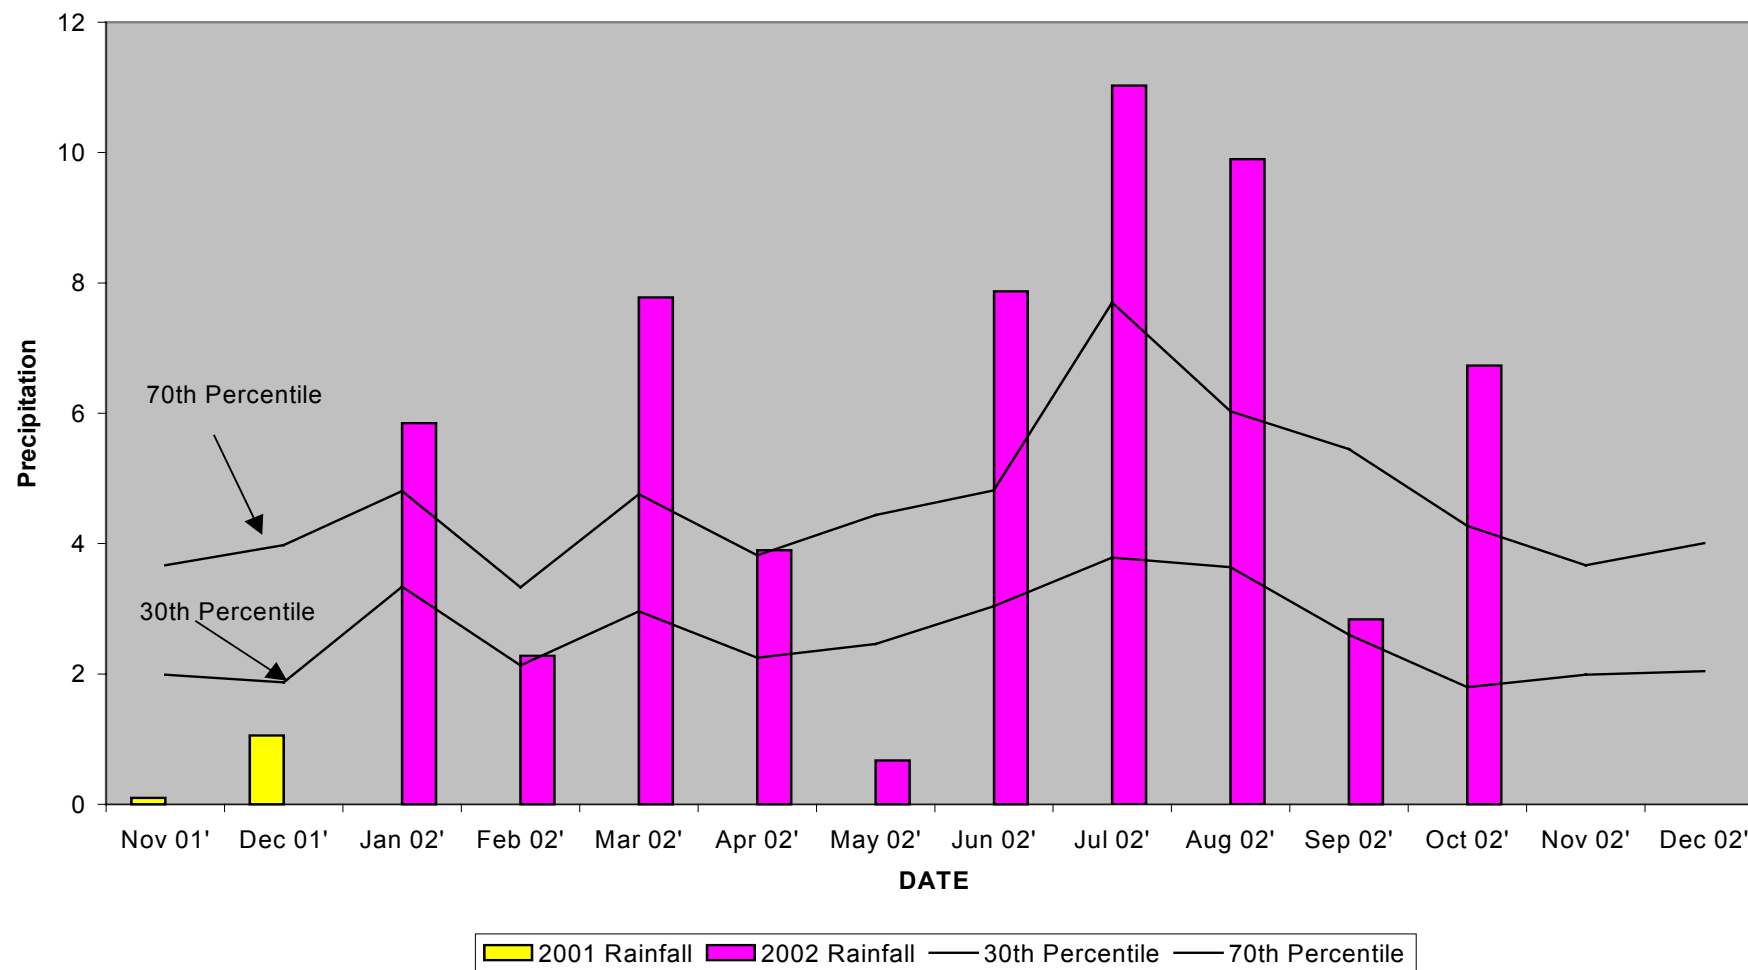
**FIGURE 4**

Figure 4 comparison of monthly rainfall for the period of November 2001 through October 2002 to historical precipitation (collected between 1971 and 2002) for Elizabeth City, North Carolina. This comparison gives an indication of how 2002 relates to historical data in terms of climate conditions. The NC State Climate Office provided all off-site data. February and May experienced below average rainfall. The months of April and September all recorded average rainfall for the site. January, March, June, July, August, and October experienced above average rainfall. No data is available for November or December however; the site meets hydrologic success criteria without these data.

**Tucker 30-70 Percentile Graph 2002  
Elizabeth City, NC**
